***IN-SITU TESTS OF THREE
BENTS AT SOUTH TEMPLE
BRIDGE ON INTERSTATE 15 –
FINAL REPORT***

**Civil & Environmental
Engineering Department
University of Utah
Salt Lake City, Utah**

**Utah Department of Transportation
Research Division**

June 2003

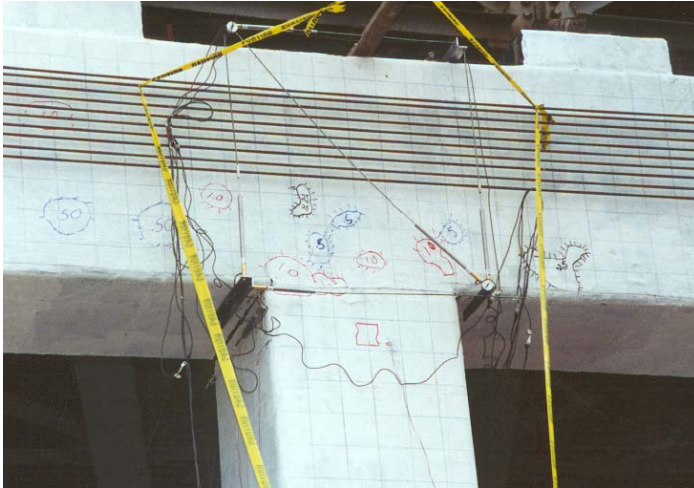
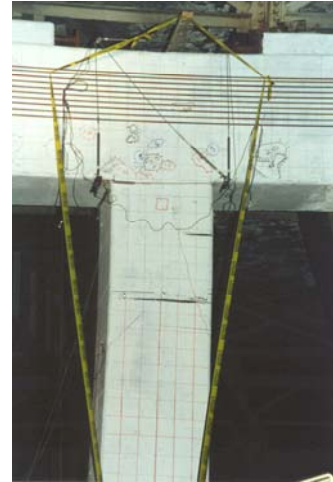
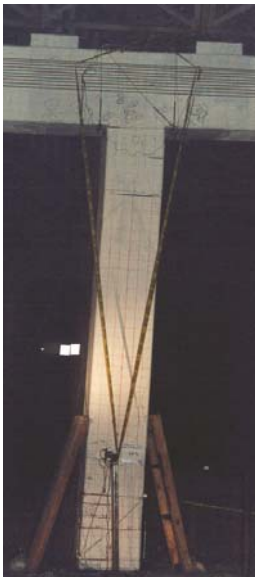
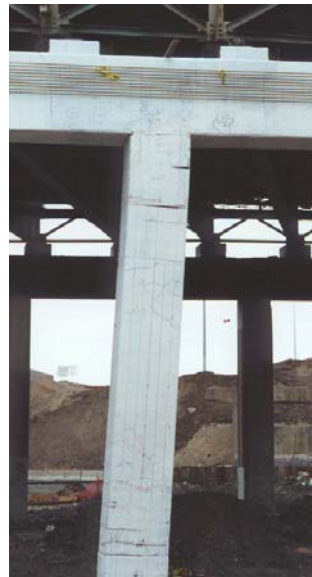
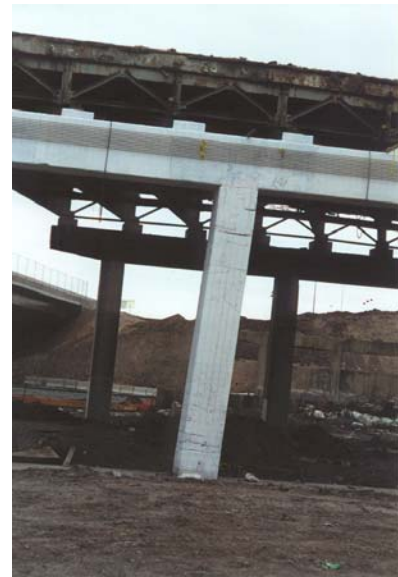
Figure 4.99 Surface damage for Middle column-cap beam joint

Phase I $0 \leq \text{time} \leq 3,000$ $0\% \leq \text{drift} \leq 0.5\%$	Phase II $3,000 \leq \text{time} \leq 17,000$ $0.5\% \leq \text{drift} \leq 3.8\%$	Phase III $17,000 \leq \text{time} \leq 25,500$ $3.8\% \leq \text{drift} \leq 5.5\%$	Phase IV $\text{time} \geq 25,000$ $\text{drift} \geq 5.5\%$
Ankle Wrap or Diagonal Layers	No onsite documentation	Small pockets of CFRP composite delaminated on the cap beam section only. See Figure 4.99(a)	1) Additional phase II CFRP composite delaminated 2) Degradation to the top column's plastic hinge region. See Figure 4.99(b)	After the East and West U-straps failure full plastic hinge has developed in the upper column. See Figures 4.99(c)-(e)
Zero Layers.	No loss in tensile capacity	No loss in tensile capacity. See Figure 4.99(a)	No loss in tensile capacity. See Figure 4.99(b)	No loss in tensile capacity. See Figures 4.99(c)-(e)
U-Strap Layers	Small delaminating in cap beam region of joint.	Small delaminating in cap beam region of joint. See Figure 4.99(a)	Small additional delaminating in cap beam region of joint. See Figure 4.99(a)	U-straps remain in good condition throughout entire test. See Figures 4.99(d), (e)

Column CFRP Composite Confinement layers	No onsite documentation	1) Layers delaminate from columns 2) Lateral flexural damage to confinement layers as plastic hinge develops. See Figure 4.99(d)	Additional lateral flexural damage to phase II confinement layers as plastic hinge develops. See Figure 4.99(e)	Additional lateral flexural to phase III damage as plastic hinge fully develops. Full hinge has developed in lower middle column reducing demand at top of column
Longitudinal Bar Yielding	No apparent de-bonding of reinforcement bar.	1) No apparent de-bonding of reinforcement bar 2) Plastic hinge is beginning to form 2) All yielding occurred in phase II. See Figures 4.80 and 4.82	No apparent de-bonding of reinforcement bar. Further development of plastic hinge	No apparent de-bonding of reinforcement bar. Full plastic hinge developed in column

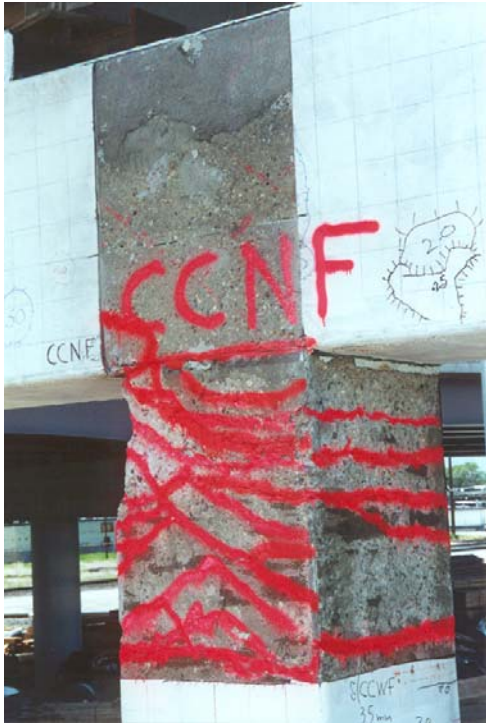
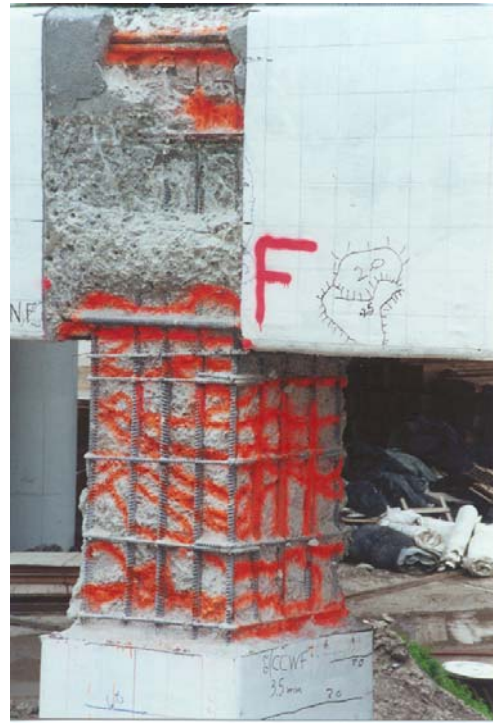
Figure 4.100 Internal damage for Middle column–cap beam joint

After removal of the CFRP layers, onsite observations showed that the cap beam portion of the middle column-cap beam joint received no damage for the duration of the test. The extent of the damage sustained for the middle joint was absorbed entirely by the top column's plastic hinge region, as shown in Figure 4.100(a). Also, after the concrete cover was removed from the middle column-cap beam joint, onsite observation found that all the concrete cover was intact and there was no longitudinal reinforcement steel de-bonded and no gaps opened at the top of the rebar in the joint region, as shown in Figure 4.100(b).

(a) after removal of the CFRP composite

(b) after removal of the concrete cover

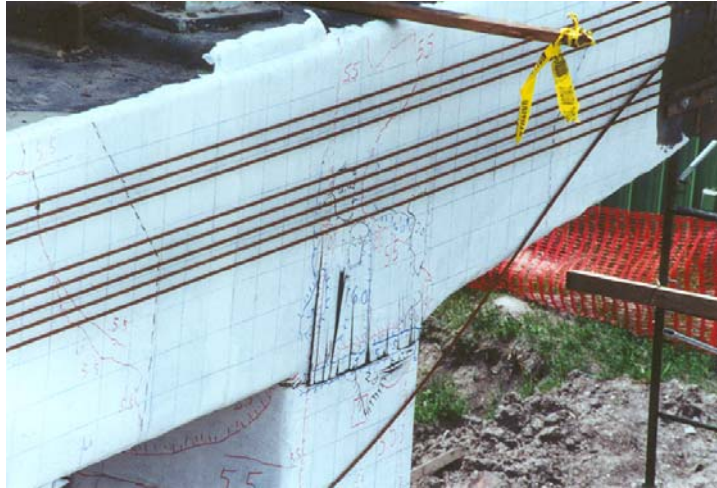
Figure 4.102 West column-cap beam joint ankle (diagonal) wrap and U-strap damage up to the maximum drift of 6.8%

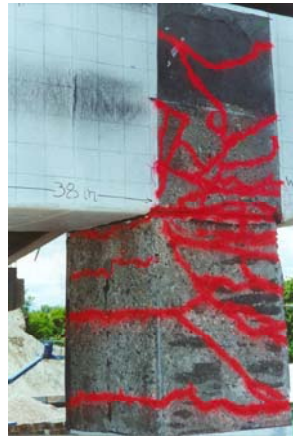
Figure 4.104 West column-cap beam joint after CFRP composite layers were removed exposing moderate flexural stresses in the plastic hinge regions of the upper column

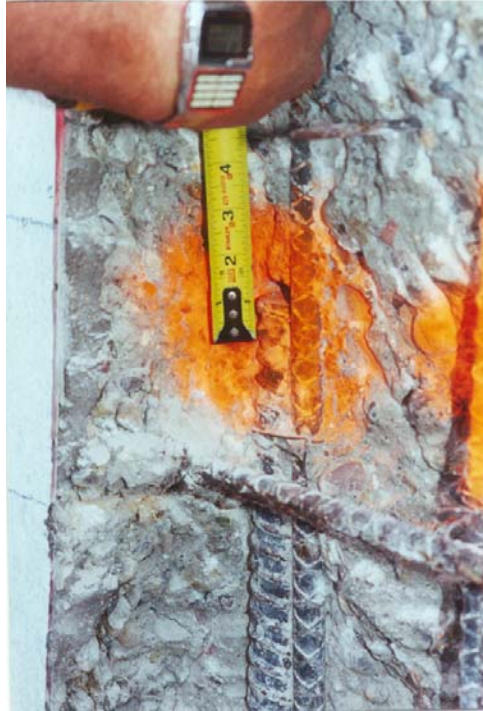
From onsite observations it was noted that there was a 16mm gap at the top of the column's longitudinal steel, as shown in Figure 4.107. The column longitudinal steel bond strength capacity was reached at approximately a 5.0% drift ratio. Once the U-straps had completely fractured, all the tensile demand was transferred to the longitudinal steel reinforcement, as shown in Figure 4.105. The West U-strap completely fractured and the total tensile demand was transferred to the column longitudinal reinforcement in the joint; the bond strength was exceeded and the joint lateral force capacity severely diminished. The failure mode for the West and East cap-beam joints was the same.

Figure 4.107 Debonded column longitudinal bar observed in the joint after the concrete cover was removed from the West column-beam joint

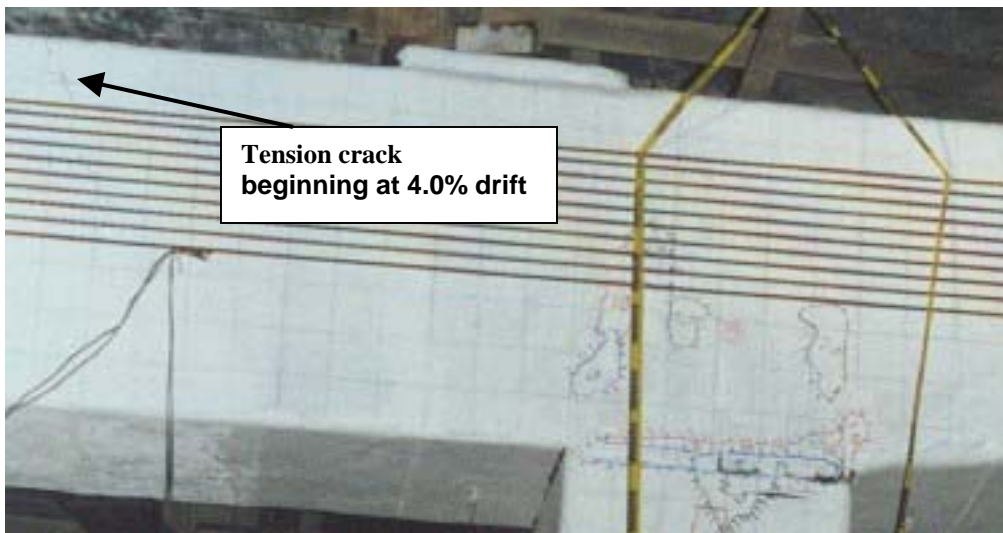
There was additional damage sustained on the cap beam slightly east of the West column cap beam joint. A tension crack formed starting at the top elevation of the cap beam at a distance of 1.73m from the East edge of the column. From onsite observations, the crack started to develop at approximately 4.0% drift, as shown in Figure 4.108; the crack propagated at a vertical descent adjacent and parallel to the cap beam CFRP composite confinement layers until reaching the soffit of the cap beam, as shown in Figure 4.109. This is also the East end point of the bottom row of 4-#10 rebar in the double row of negative moment longitudinal reinforcement steel installed at the top elevation of the West joint of the cap beam, as shown in Figure 4.110. The crack continued to propagate diagonally and had completely developed at a displacement drift of 5.5%. The ending point of the diagonal portion was approximately 1.0m east of the East face of the West column at an elevation approximately 280mm vertically up from the soffit of the cap beam.

Figure 4.108 Beginning of the tension crack at 4.0% displacement drift

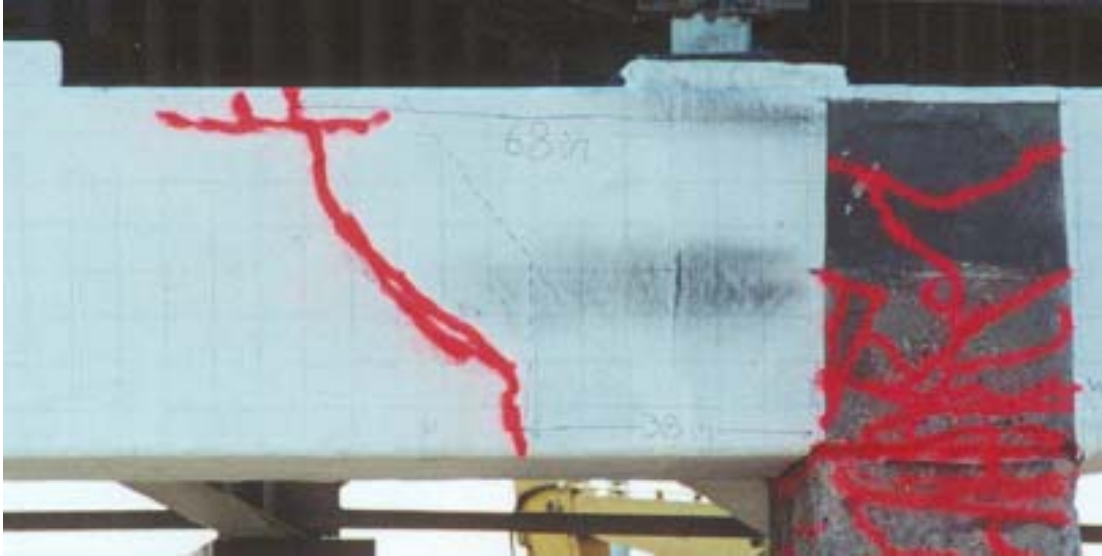
Figure 4.109 Flexural tension cracked cap beam section east of the West column: beginning at 4.0% drift ratio and ending at 5.5% drift

The size of the negative moment at 1.73m east of the East face of the West column, where the flexural tension crack first began, was estimated as 2,118kNm or 72% of the maximum negative moment located on the center cap beam West joint. This was the most likely region to fail because of the high negative moment and the insufficient tensile steel reinforcement and the absence of CFRP composite zero layers to develop enough tensile capacity in the top elevation of the cap beam to prevent yielding. From simulation results (Duffin 2003), it can be theorized that the flexural tension crack could have been prevented if two CFRP composite layers were applied to both the North and South faces of the cap beam.

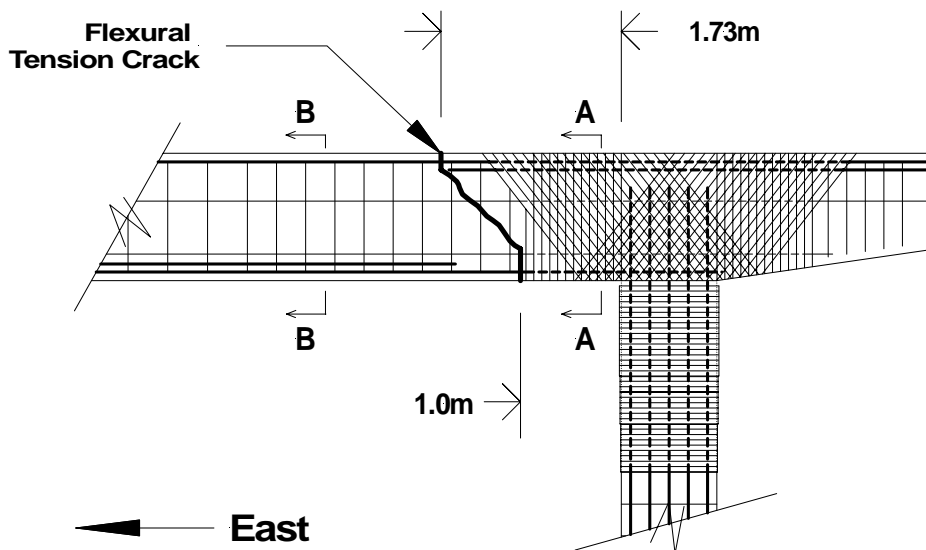
Figure 4.110 Tension crack relative to the negative moment longitudinal reinforcement steel and the CFRP confinement adjacent to the West column

As stated earlier, the flexural tension crack began at the East end of the bottom row of the 4-#10 rebar located at the top of the cap beam negative reinforcement steel, but this also shows that the top row of the 8-#10 rebar had to yield for the crack to be able to begin. Also, the vertical last portion of the crack that ran adjacent to the CFRP composite was approximately the same height as the compression block estimated from the DRAIN-2DX as 254mm.

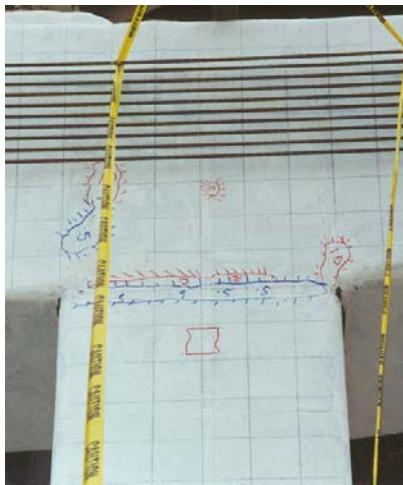
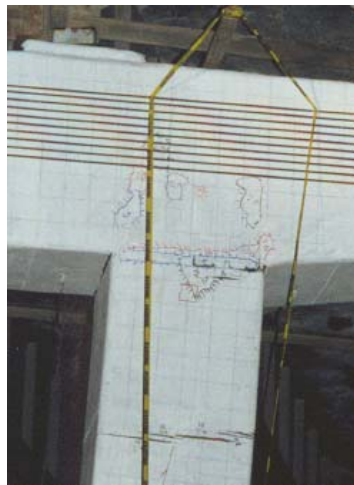
Figure 4.111 Surface damage for West column-cap beam joint

Phase I $0 \leq \text{time} \leq 3,000$ $0 \leq \text{drift} \leq 0.5$	Phase II $3,000 \leq \text{time} \leq 17,000$ $0.5 \leq \text{drift} \leq 3.8$	Phase III $17,000 \leq \text{time} \leq 25,500$ $3.8 \leq \text{drift} \leq 5.5$	Phase IV $\text{time} \geq 25,000$ $\text{drift} \geq 5.5$
Ankle Wrap or Diagonal Layers	No onsite documentation	At 1.0 drift small delaminating on cap beam around U-strap region. See Figure 4.111(a)	Additional delaminating to phase II. See Figure 4.111(b)	Some additional delaminating layers to phase III, but joint stress reduces after U-straps fracture and rebar de-bonds. See Figure 4.111(c)
U-Strap Layers and cap beam confinement layers	No degradation of U-straps. See Figure 4.111(a)	U-straps begin to fail at approximately 3.73% drift.	Failure of the West U-continues until 5.5% drift. See Figures 4.105 and 4.111(b)	Complete fracture of West U-strap. Further degradation would have occurred on the East U-strap but maximum drift for pull cycle was 1.4% See Figure 4.111(c)

Confinement Layers	No lateral flexural cracks formed in CFRP composite layers	Lateral flexural cracks in confinement layers begin approximately 1.0% drift	Lateral flexural cracks do not increase after U-straps begin to fail and rotation is transferred to the bottom grade beam joint	Lateral flexural cracks do not increase after U-straps begin to fail and rotation is transferred to the bottom grade beam joint
Longitudinal Bar Yielding and column bar pullout	No yielding from strain gages	1) No yielding in strain gages 2) All yielding occurred in phase II. See Figure 4.80	The column longitudinal reinforcement in the column and in cap beam yielded SG63 and SG64 at 4.0% drift. See Figure 4.105	1) Longitudinal rebar pulled out at 5.5%. See Figure 4.107 2) Longitudinal bar de-bonded before concrete demand was greater than the confined concrete capacity
Cap beam tension crack	No cracking	No cracking	Lateral flexural crack begins at the top elevation of cap beam at 4.0% drift and continues to crack to the soffit of cap beam at 5.5% drift. See Figures 4.108-4.109	1) Complete failure of cap beam prevented by additional support from road deck diaphragm. See Figure 4.112 2) Light damage inside reinforcement cage due to the de-bonding of the rebar reducing the bending stresses in both the cap beam and the plastic hinge region of the column. See Figure 4.113

(a) $0.5\% \leq \text{drift} \leq 3.8\%$

(b) $3.8\% \leq \text{drift} \leq 5.5\%$

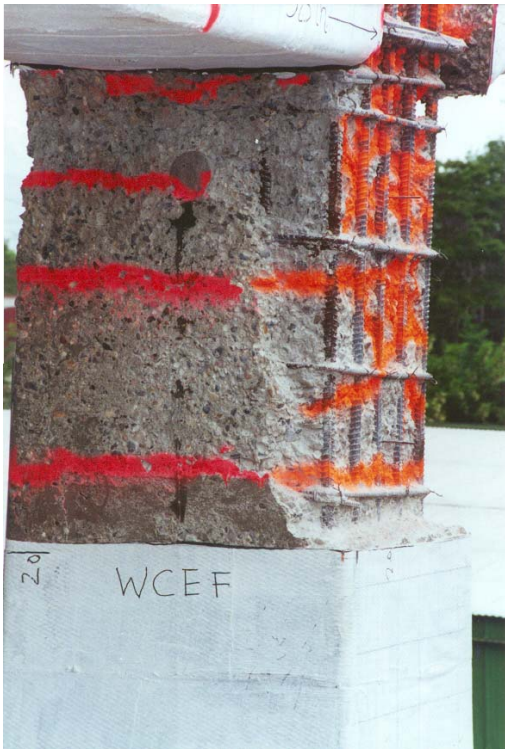
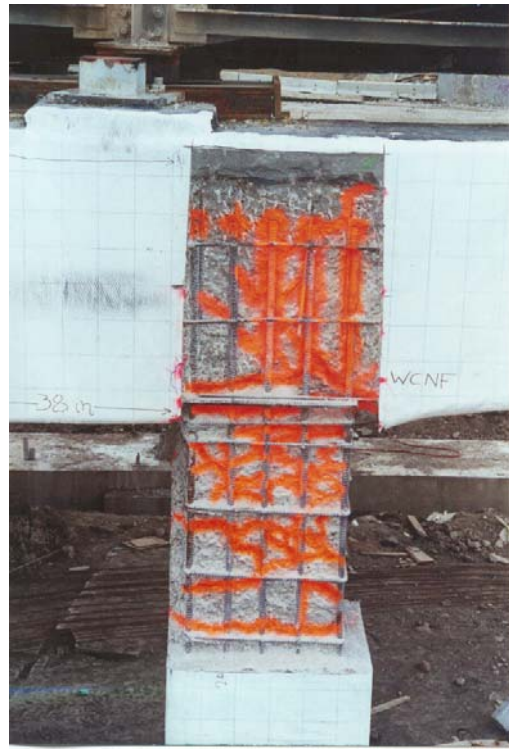
(a) East face after concrete cover was removed

(b) North face after concrete cover was removed

Figure 4.113 Internal damage for West column–cap beam joint

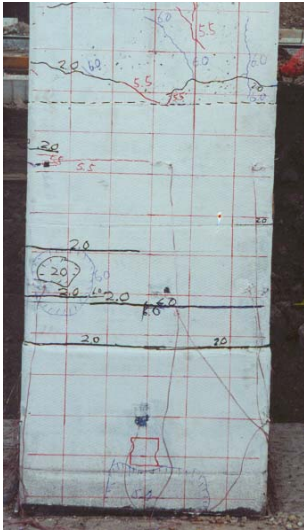
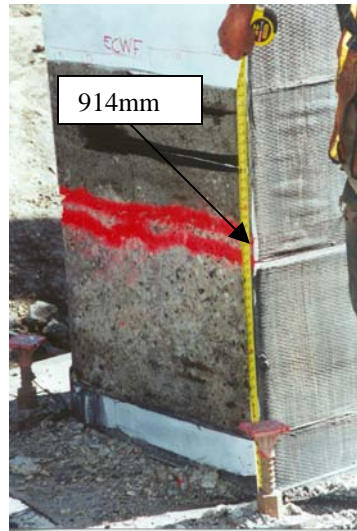
(a) Flexural cracking

(b) Flexural cracking

Figure 4.115 Surface damage and deterioration for East column-grade beam joint

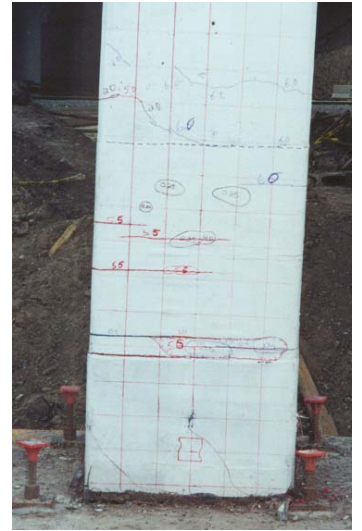
(c) Lap splice pull-out

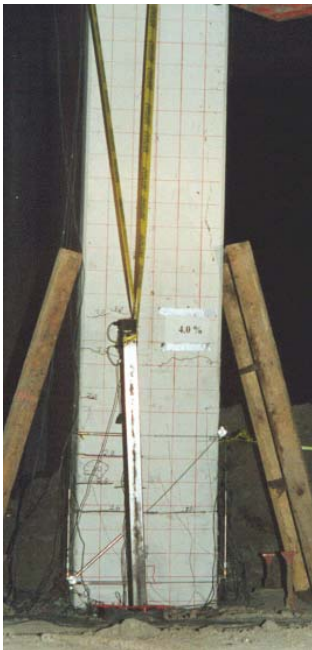
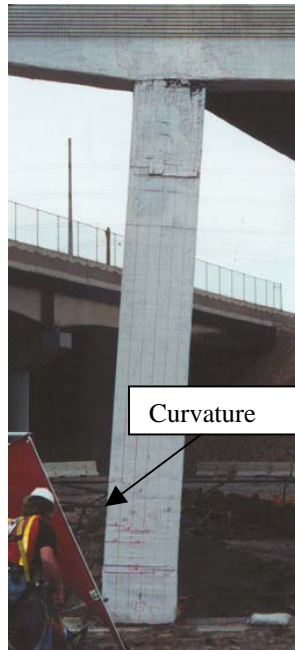
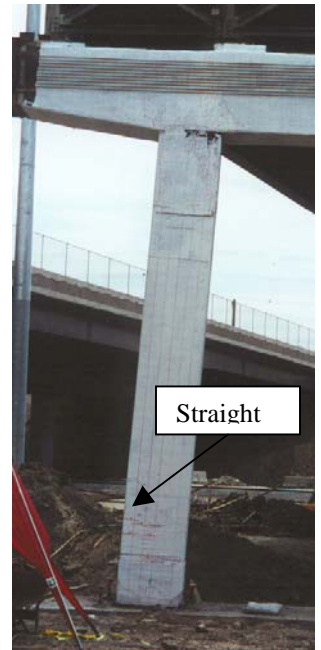
Lap-splice pull-out	No damage	No damage	No damage	1) Slight amount of bar pull out on the East side of the column base after 6.0% drift. 2) Observe the difference in elevation between the East and West column base elevations. See Figure 4.115(f)
Fixed end column-cap beam and fixed end column-grade beam joints	Column end connections are fixed-fixed. See Figure 4.115(d)	Column end connections are fixed-fixed. See Figure 4.115(d)	NA	NA
Hinged end column-cap beam and fixed end column-grade beam joints	NA	NA	Column connections are plastic hinged-hinged. Column has curvature at bottom plastic hinge region. See Figure 4.115(e)	NA
Hinged end column-cap beam and semi fixed at the column-grade beam	NA	NA	NA	Column connections are semi fixed-hinged hinged. The column straightens and un-even gap at the column-grade beam interface. See Figure 4.115(f)

(d) Fixed-fixed

(e) Fixed-hinged

(f) Semi fixed-hinged

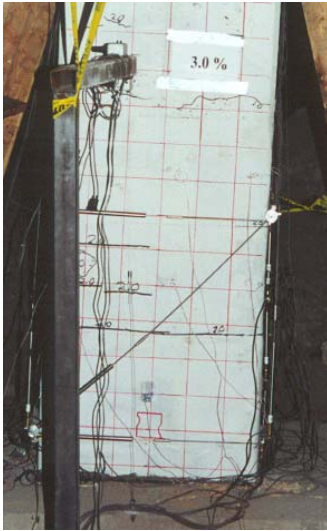
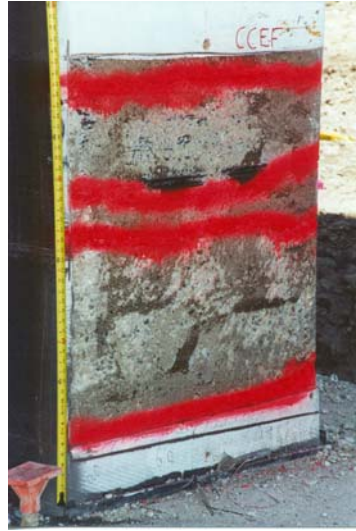
(a) $0.5\% \leq \text{drift} \leq 3.8\%$
Flexural cracking
above plastic hinge

(b) Flexural cracking after
confinement layers were
removed

Figure 4.120 Surface damage and deterioration for East column-grade beam joint

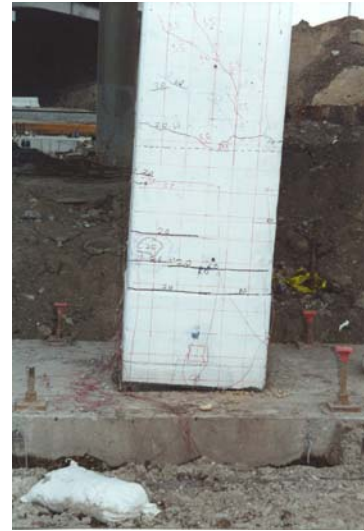
Lap-splice pull-out	No damage	No damage	No damage	Slight amount of bar pull out on the East side of the column after 6.0% drift. See Figure 4.120(d)
Fixed end column-cap beam and fixed end column-grade beam joints	Column end connections are fixed-fixed. See Figure 4.115(d)	1) Double curvature formed for a fixed-fixed column 2) Plastic hinges developed in the top portion and the bottom portion of the 3 layers above as-built plastic hinge region in the middle column at 3.73% drift. See Figure 4.120(b)	NA	NA
Plastic hinged end column-cap beam and plastic hinged end column-grade beam joints	NA	NA	Column connections are plastic hinge-plastic hinged. Column has curvature at bottom region. See Figure 4.115(e)	NA
Hinged end column-cap beam and semi fixed at the column-grade beam	NA	NA	NA	Column connections are semi-fixed-plastic hinged. The column straightens and uneven gap at the column-grade beam interface. See Figures 4.120(d), 4.120(e)

(c) $\text{drift} \geq 6.0\%$ Lap splice pull-out

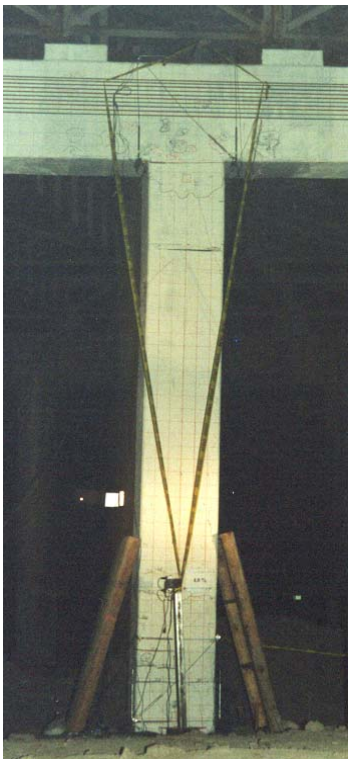
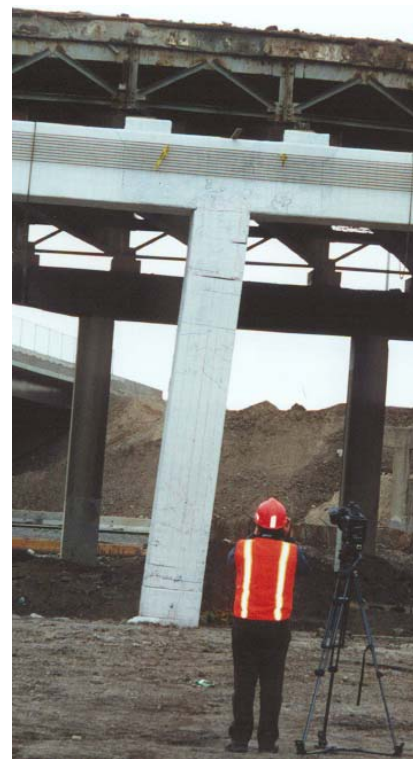
(d) $0.5\% \leq \text{drift} \leq 3.8\%$ Double curvature

(e) $\text{drift} \geq 6.0\%$ Full development of top and
bottom plastic hinges

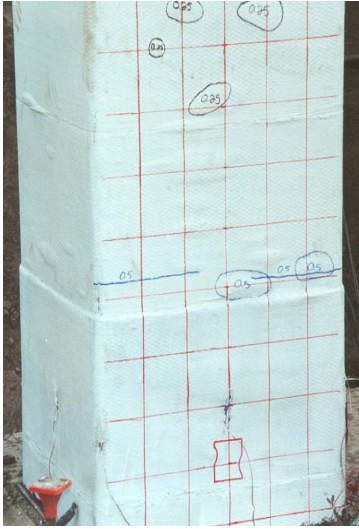
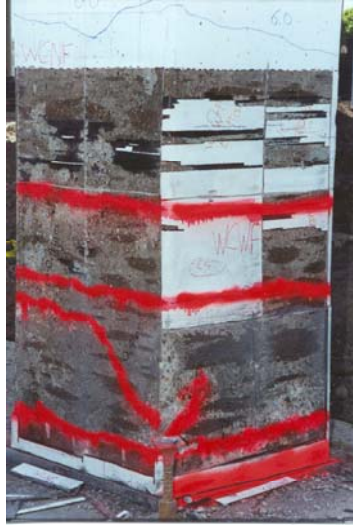
(a) Flexural cracking

(b) Flexural cracking

Figure 4.122 Surface damage and deterioration for West column-grade beam joint

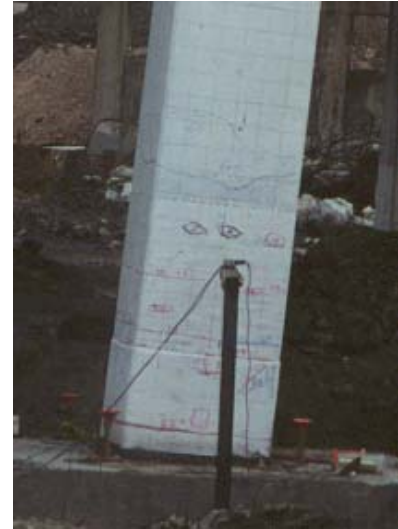
(c) Lap splice pull-out

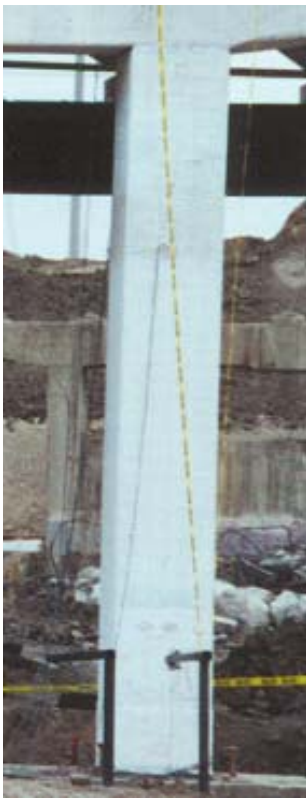
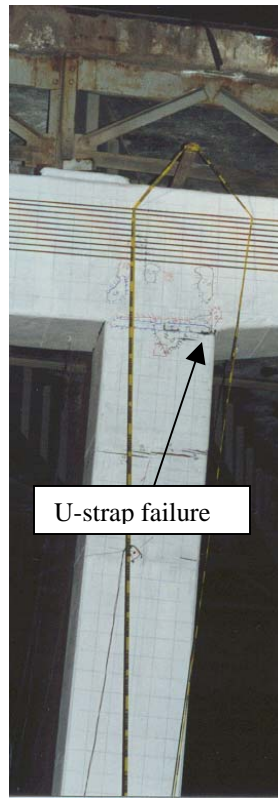
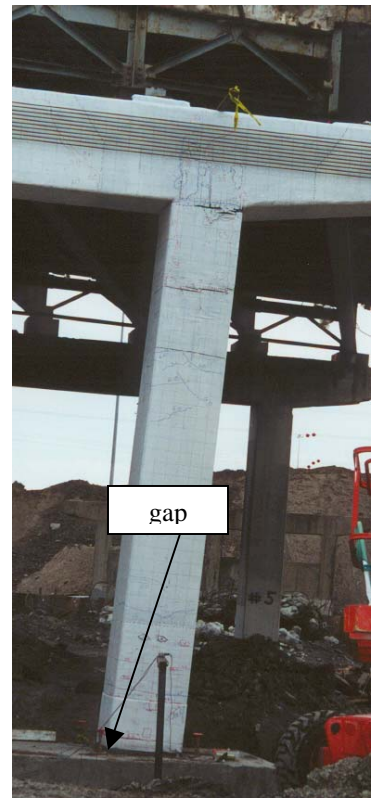
Lap-splice pull-out	No damage	No damage	No damage	1) Slight amount of bar pull out on the East side of the column base after 6.0% drift. 2) Observe the difference in elevation between the East and West column base elevations. See Figure 4.122(d)
Fixed end column-cap beam and fixed end column-grade beam joints	Column end connections are fixed-fixed. See Figure 4.122(d)	Column end connections are fixed-fixed. See Figure 4.122(d)	NA	NA
Hinged end column-cap beam and fixed end column-grade beam joints	NA	NA	Column connections are plastic hinged-hinged. Column has curvature at bottom plastic hinge region. See Figure 4.122(e)	NA
Hinged end column-cap beam and semi fixed at column-grade beam joint	NA	NA	NA	Column connections are semi fixed-hinged. The column straightens and uneven gap at the column-grade beam interface. See Figure 4.122(f)

(d) Fixed-fixed

(e) Fixed-hinged

(f) Semi fixed-hinged

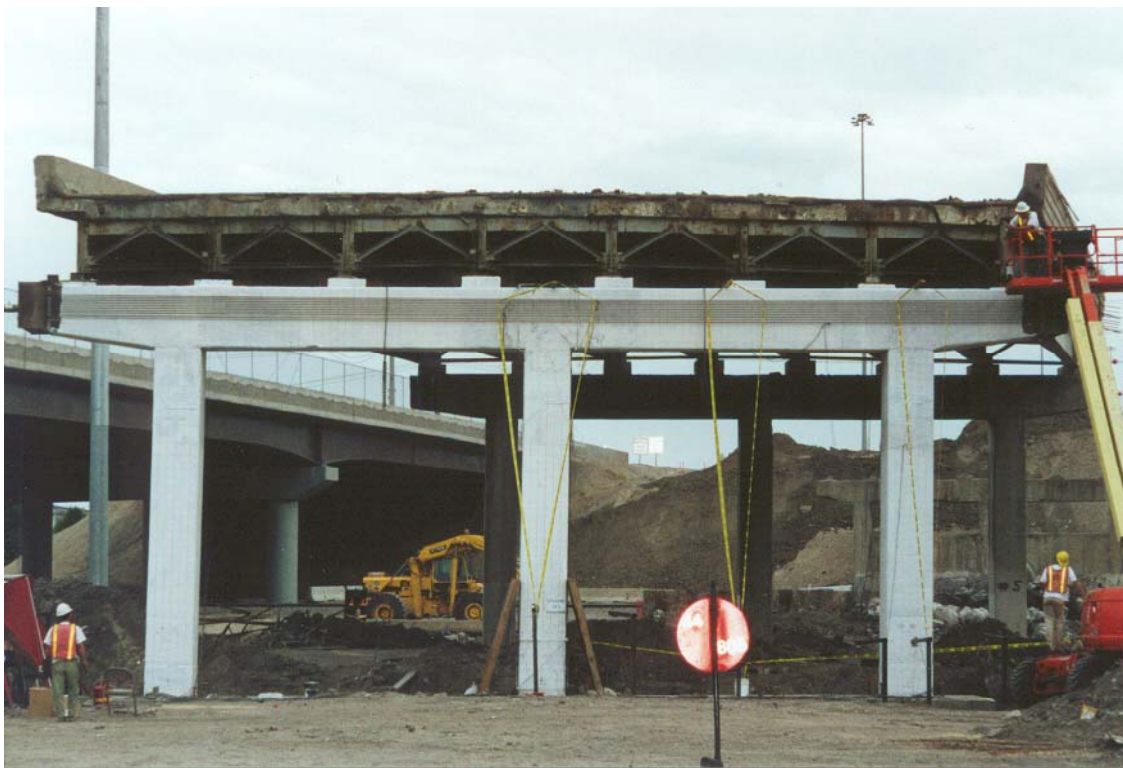
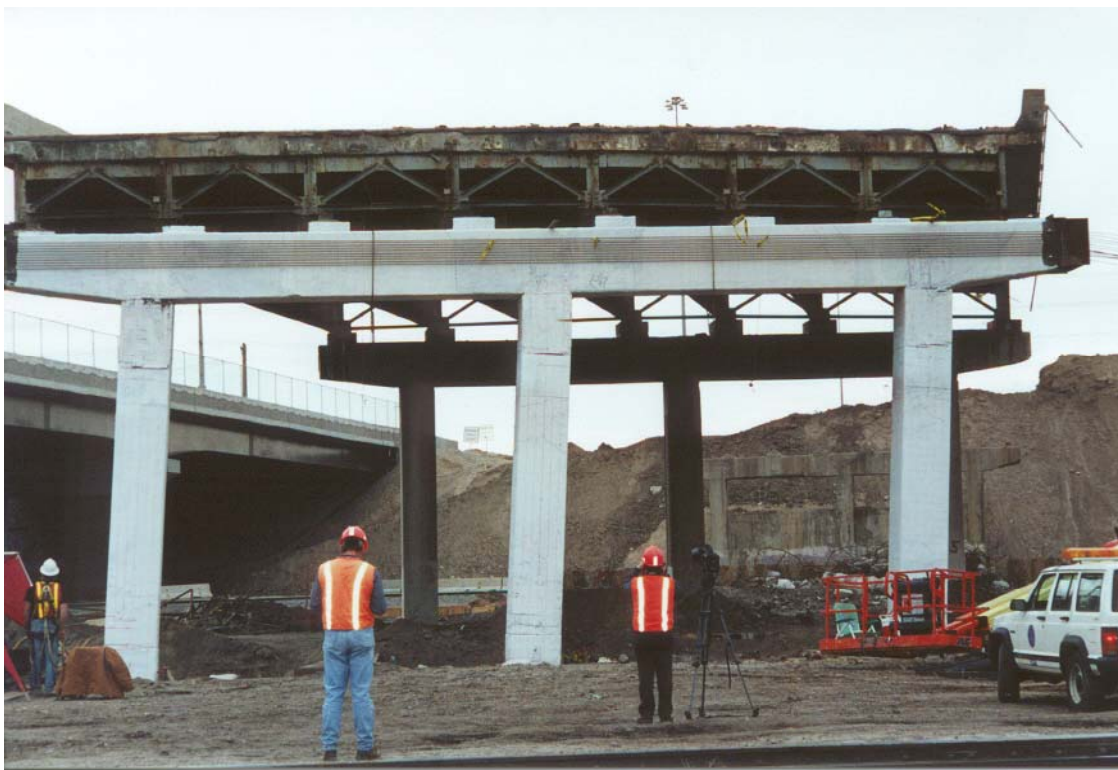
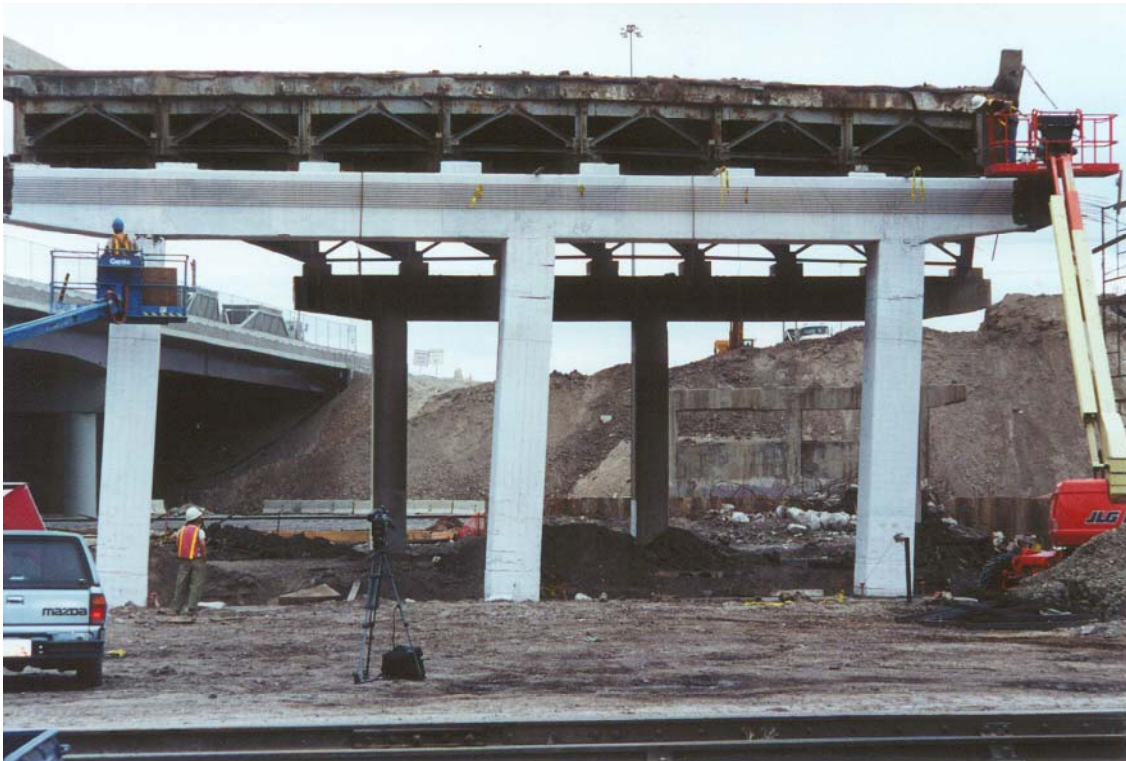
From onsite observations, for displacement drifts between 4% and 6%, the tops of the two exterior columns pivot at the column-cap beam interface and start rigid-body rotation; at the bottom, the two exterior columns rotate approximately 700mm above the top of the grade beam where the plastic hinge develops. The Middle interior column forms two well defined plastic hinges approximately 1000mm below the cap beam soffit at the column top and 650mm above the grade beam at the bottom of the column, as shown in Figures 4.126 and 4.127. The connectivity of the exterior column end connections for drifts between $4.0\% \leq \text{drifts} \leq 6.0\%$ would be considered plastic hinged at the bottom and hinged at the top; for the interior column, the connectivity would be plastic hinge at both the top and bottom.

When the bent structure was displaced at a drift ratio between 6.0% and the ending test drift ratio of 6.8%, the bottom column-grade beam joint fixity became semi-fixed and it was observed that there was some bar slippage in the lap splice regions. The fundamental failure patterns observed and performance levels during the May 6-9, 2000, Bent #6S test are presented in a final matrix. The matrix correlates all six of the individual joints and focuses on critical failure modes observed during the test. As the structure was displaced, the joints of the structure degraded; the structural degradation transition is represented using three different structures defined as Phase I, II, and III, in the interval between $0\% \leq \text{drift} \leq 6.8\%$. Phase I is defined between $0\% \leq \text{drift} \leq 4.0\%$ in which all three columns were in double curvature; both ends of all the columns are fixed-fixed connections. Phase II is defined between $4.0\% \leq \text{drift} \leq 6.0\%$ during which the exterior column U-straps fracture and the longitudinal reinforcement in the exterior column-cap beam joints starts to pullout. The Middle joint U-straps and longitudinal reinforcement steel remained intact, but full plastic hinge pivot points developed in the top and bottom portions of the column. Also, plastic pivot points formed at the base of the East, Middle, and West columns just above the bottom 14 CFRP composite confinement layers. It should be noted that the plastic hinge pivot point was located

Figure 4.125 Onsite Phase I Bent #6S 2000 deflected shape between up to 4.0% drift ratio

Figure 4.127 Onsite Phase II Bent #6S 2000 deflected shape up to 6.0% drift ratio

Figure 4.129 Onsite Phase III Bent #6S 2000 deflected shape at 6.8% drift ratio
